ADVANCED MASTERS IN STRUCTURAL ANALYSIS
OF MONUMENTS AND HISTORICAL CONSTRUCTIONS

Master's Thesis

Mechanical characterization of traditional connections in half-timbered walls: experimental results and retrofitting solutions

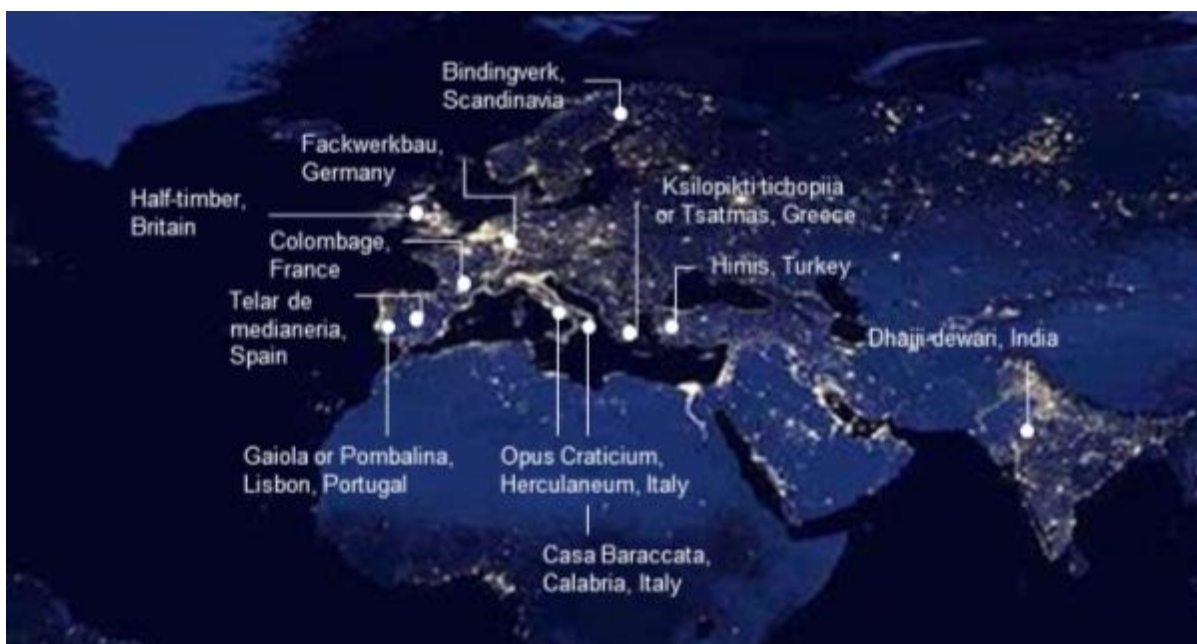
Figure 2.2 – Local names to describe the studied structure [7],[8],[9].

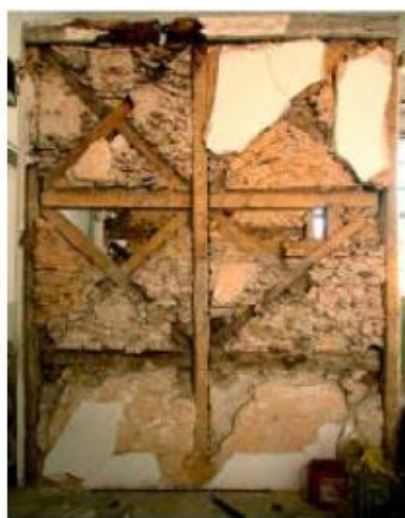
Figure 2.14 – a) Removed wall from “Pombalino” building and tested for strength and stiffness in the Portuguese National Lab by Coias e Silva, b) F-d graph of one from the three walls that were tested, which shows that structural integrity was not lost [7].

- iv) Finally, the consideration or not of the masonry infill and the material properties that will be used [2],[17].
- Finally, helpful information to the scientific community is provided through the performance of experiments on real size walls which are either manufactured [4],[15] or removed from buildings (Figure 2.14) [7]. In the first case it is possible to perform tests on walls with or without infill and openings as well. Additionally, it is possible to examine the cases of repairing, strengthening and rehabilitation [20],[21]. Such a research is ongoing at the moment at the University of Minho in Portugal (Figure 2.15) [4].

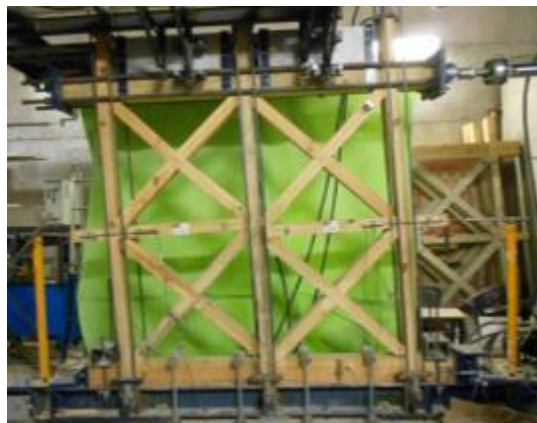
Figure 2.15 – a) Timber-framed wall without infill tested at the University of Minho, Portugal, b) Corresponding F-d graph for the lower considered vertical load (25kN) [4].

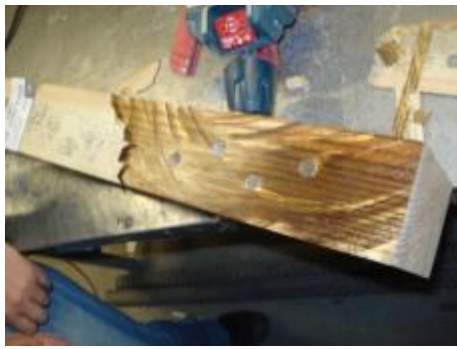
Figure 4.2 - Photos a) - i) show the application procedure of the GFRP sheets on the fixing point of the posts and j) the laterally placed screws.

Shallow grooves of 2÷3mm were made to the front and posterior, upper parts of the post with a height equal to the one that is required from the steel profile (Figure 4.2a). After that, the area where the FRP would be applied was roughened with sandpaper and particles of wood along with dust were removed (Figure 4.2b).

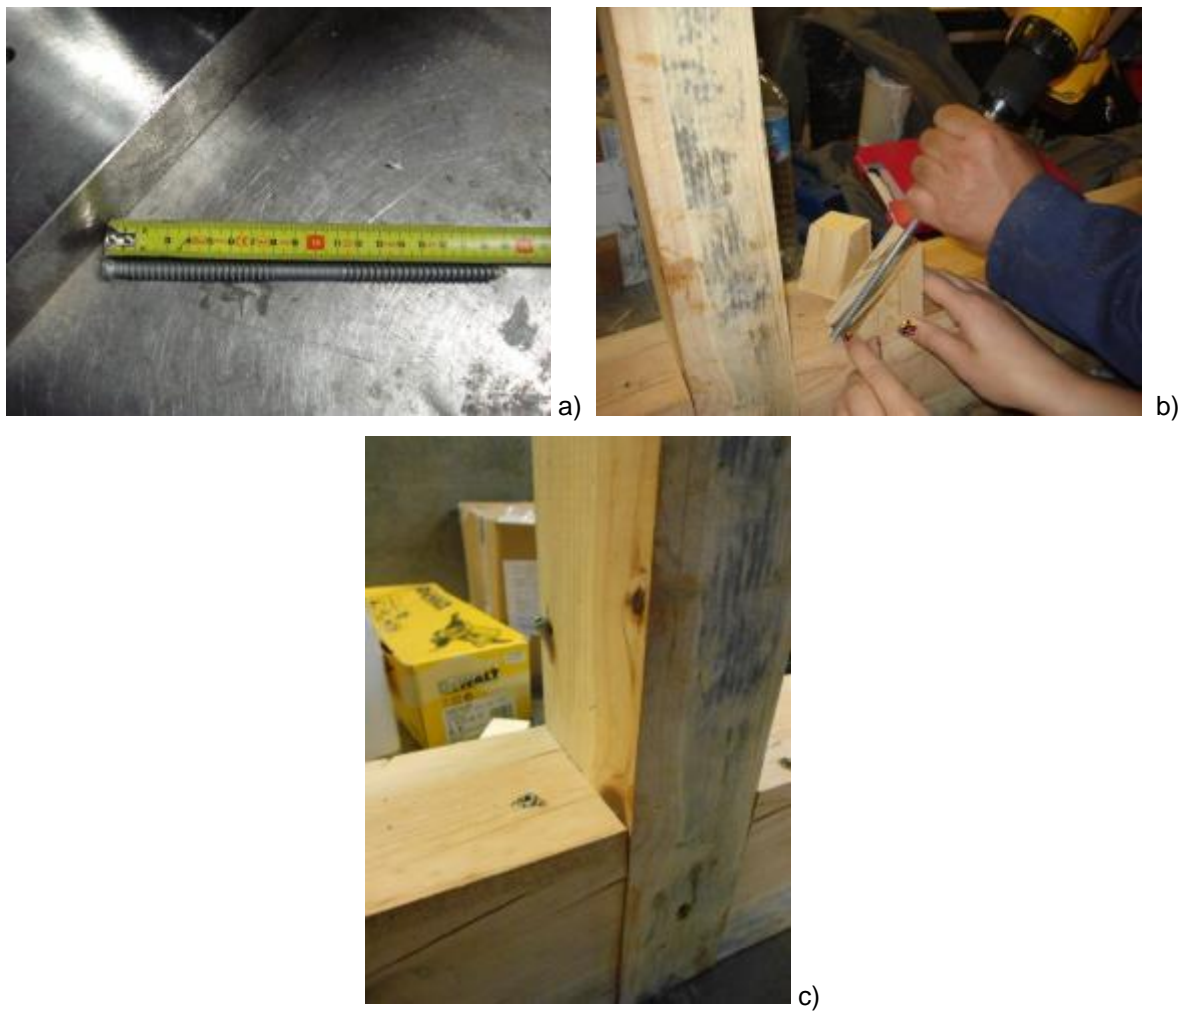
Figure 4.3 - a) Self-tapping screw, b) Wooden wedges were used to help follow the right angles, c) Difficulties were encountered when the screws were positioned through the posts.

In this retrofitting case, four self-tapping screws with a length of 19cm and a diameter of 8mm (Figure 4.3a), were positioned laterally of the connection; two on each side under different angles. Two were positioned through the post sides while the other two through the beam sides. The ones that penetrated from the beam sides were placed under an angle of 45° , crossing one another forming an “X” and so did the ones that entered the connection from the post sides, but with an angle of 60° . The spacing between the screws and their distances from the end and edge recommended by the standards of Eurocode 5 could not be accommodated within the small width of the specimen, 12cm so they were appropriately modified to fit in the area (Figure 4.4). Small wooden wedges were created to ensure that the angles would be easily followed (Figure 4.3b).

It was necessary that the screws would be entering through the post sides from the back point of view, in order to obtain continuity between the post and the beam, which are interrupted on this side. It should be mentioned that it was very difficult to position these two screws. The capacity of the screwing machines that were used was not enough to place them until the end and about 2,5cm was left outside on both sides (Figure 4.3c).

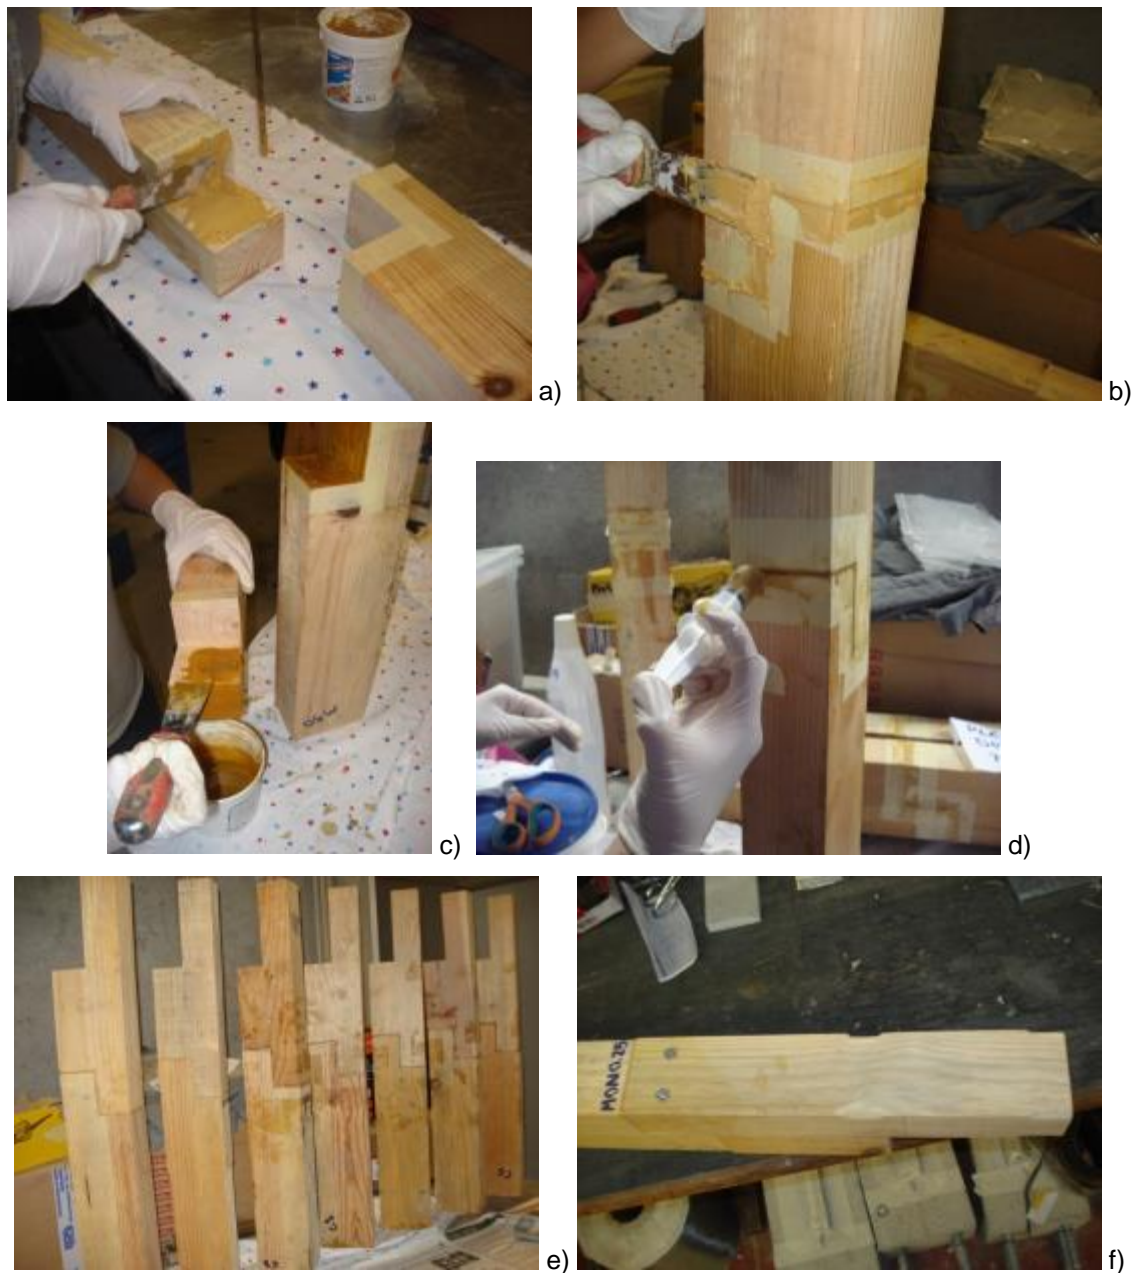
Figure 4.12 - a) - b) Application of paste glue for the prosthesis, c) Application of gel glue for the prosthesis, d) The gel was additionally filled with the help of a syringe, e) For the first two specimens on the left the prosthesis was placed with paste glue giving a better looking result, f) The positioning of the two screws at the prosthesis connection.

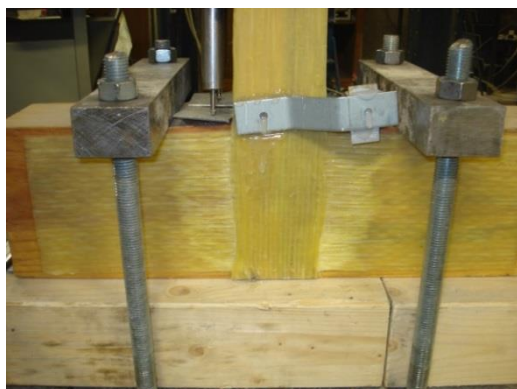
Figure 5.1 – Details of the damage patterns that were observed during the pull-out test of the specimen with “T” GFRP strengthening a) - c).

- Initially, at the front, where there is post continuity, there was debonding of the horizontal GFRP sheet, which was applied on the beam, perpendicular at the 2 intersecting sides with the post (Figure 5.1a). Further outwards propagation of the debonding upon the beam happened gradually.

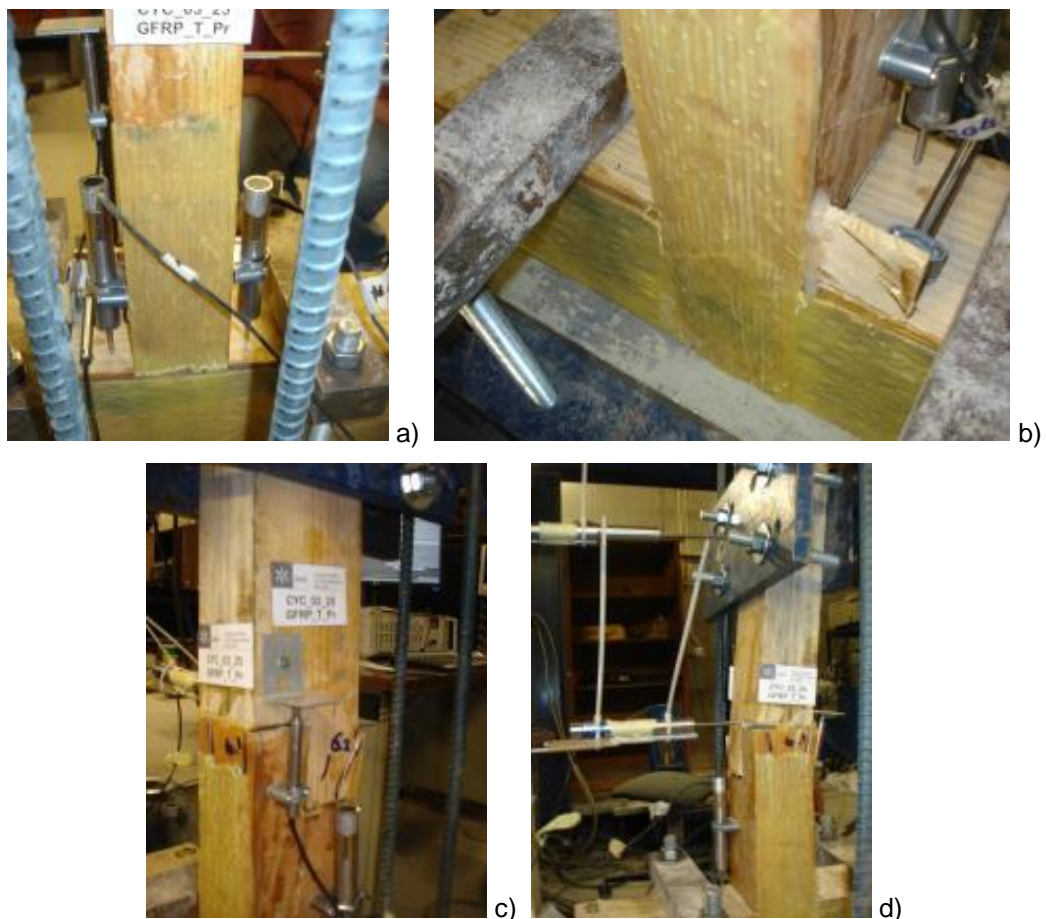
Figure 5.15 - Photos a) – d) show the progressive damage patterns that appeared during the in-plane cyclic tests of the strengthened with prosthesis and “T” GFRP specimens for a vertical load of 25kN.

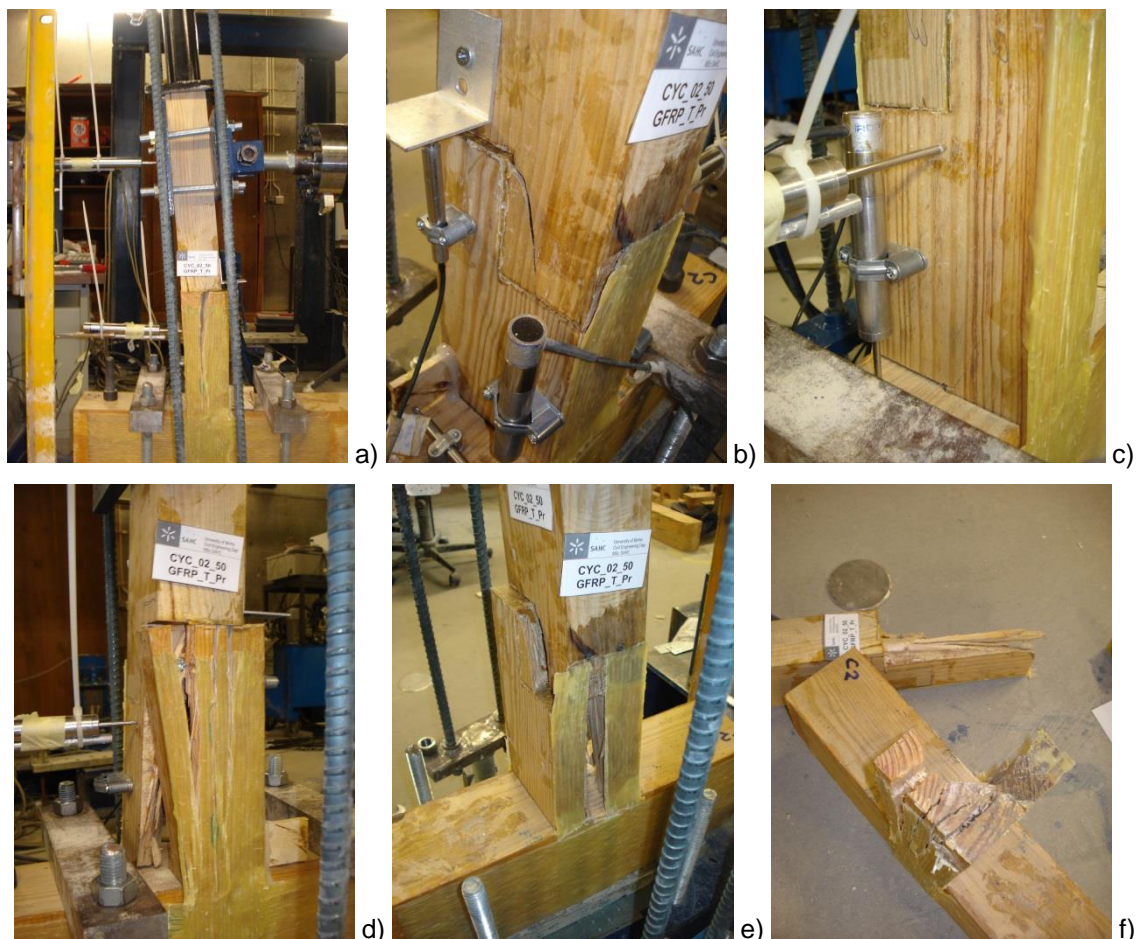
Figure 5.16 - Photos a) – e) show the progressive damage patterns that appeared during the in-plane cyclic tests of the strengthened with prosthesis and “T” GFRP specimens for a vertical load of 50kN.

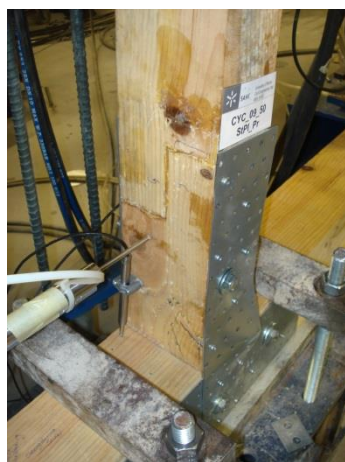
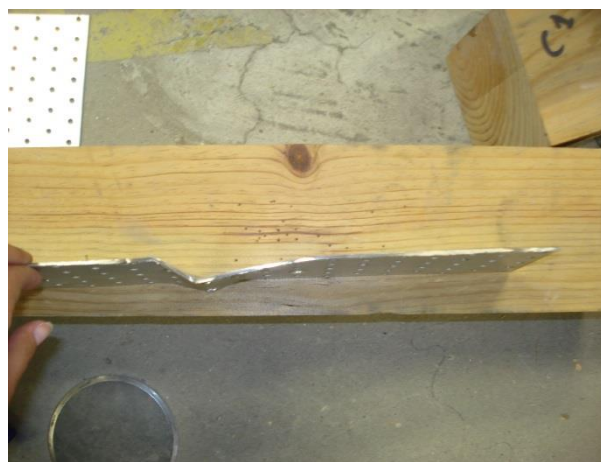
Figure 5.23 - Photos a) – c) show the progressive damage patterns that appeared during the in-plane cyclic tests of the strengthened with prosthesis and steel plates specimens for a vertical load of 50kN.

After the completion of the test, the plates were removed and the connection was dismantled. Permanent deformations were witnessed at the vertical plates (Figure 5.23b), while no apparent deformation existed on the horizontally positioned plates.
